USAAEFA-80-14

USAAEFA PROJECT NO. 80-14

**LIMITED ARTIFICIAL AND NATURAL ICING TESTS
PRODUCTION UH-60A HELICOPTER
(RE-EVALUATION)**

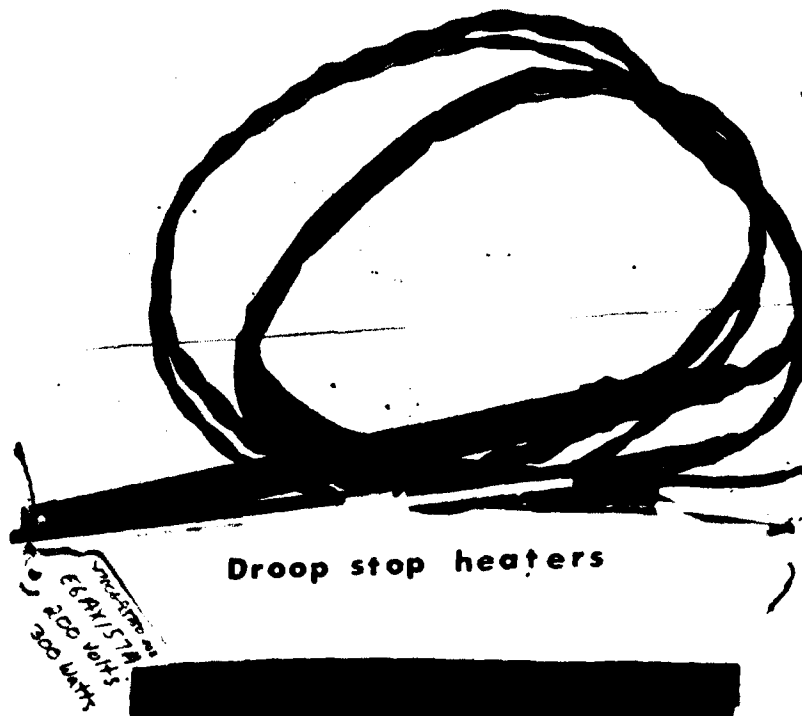
16. Droop stop anti-ice system operation test conditions are listed in table 1, appendix E. Anti-ice protection was provided by an electrically heated rod (photo 3, app G), inserted through each droop stop pivot bolt (photo 4). Five configurations of droop stops and anti-ice protection were evaluated: production droop stop (P/N 70105-08151-041) with 231 watt heater; production droop stop with 300 watt heater; production droop stop with 300 watt heater and rubber bumper removed; GCT droop stop (P/N 70105-08051-101) with 300 watt heater; and, GCT droop stop with no heater. A production droop stop, production droop stop without rubber bumper and a GCT droop stop are shown in photographs 5, 6, 7, respectively. Artificial icing test results are summarized in figure 1, appendix E. Unsatisfactory droop stop operation was defined as either partial or complete failure of the droop stop to return to the shutdown position (photo 8 and 9). Incomplete seating of the droop stops resulted in damage to the droop stop as shown in photo 10. The only droop stop configuration that demonstrated satisfactory operation at all conditions tested was the GCT droop stop with the 300 watt heater installed. Three natural icing flights were accomplished in this configuration to verify the artificial icing test results. A combination of the greater thermal conductivity along the larger counterweight attachment arms and lower catch efficiency of the larger counterweight was probably responsible for the demonstrated satisfactory performance of this configuration. The government competitive test droop stop with 300 watt heater operated satisfactorily at all conditions tested.

Photo 3. Droop Stop Heater, Uninstalled

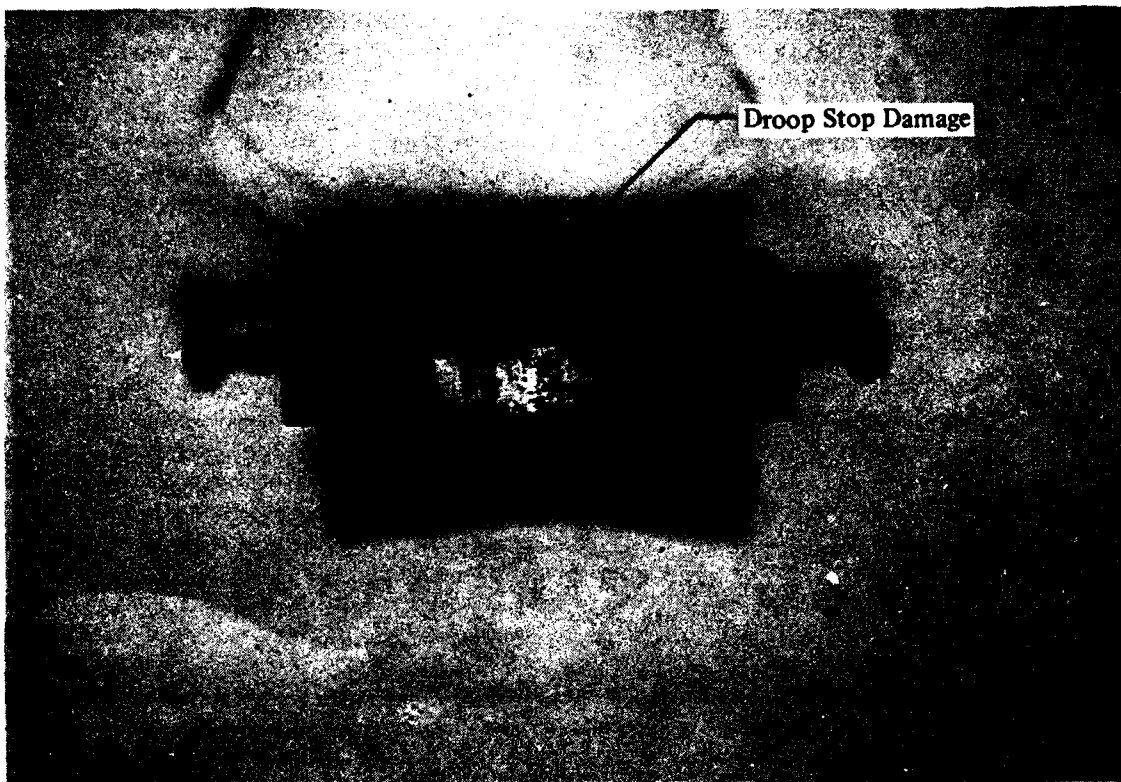
Photo 10. Droop Stop Damage Due to Shutdown with Droop Stop Being Not Fully Seated

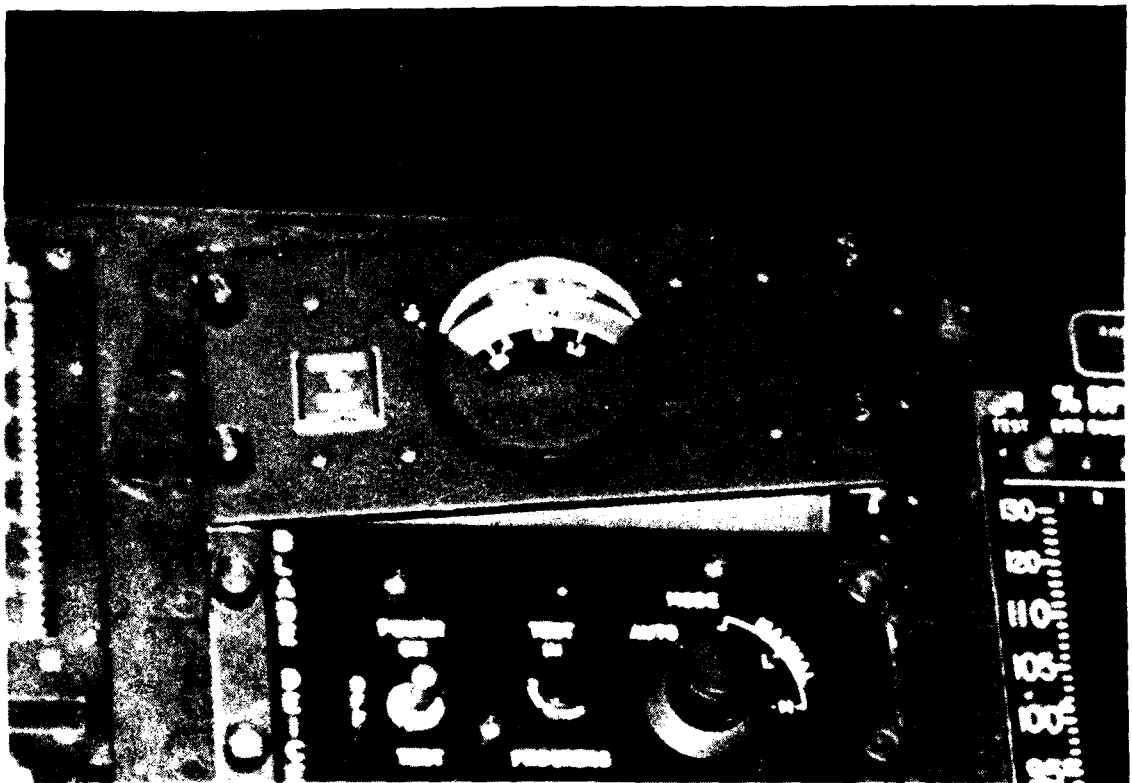
28. Previous testing had identified the poor location (pilot's panel) and readability (caused by parallax from the copilot's station and recessed face) of the icing rate meter as a shortcoming. For this test the previous icing rate meter installation was canted 10 degrees toward the copilot (photo 17, app G). The readability of the icing rate meter from the copilot's station was improved. The readability of the icing rate meter is satisfactory.

Photo 17. Canted Icing Rate Meter
